2012 - Mazda6 - Body and Accessories

VANITY MIRROR ILLUMINATION INSPECTION

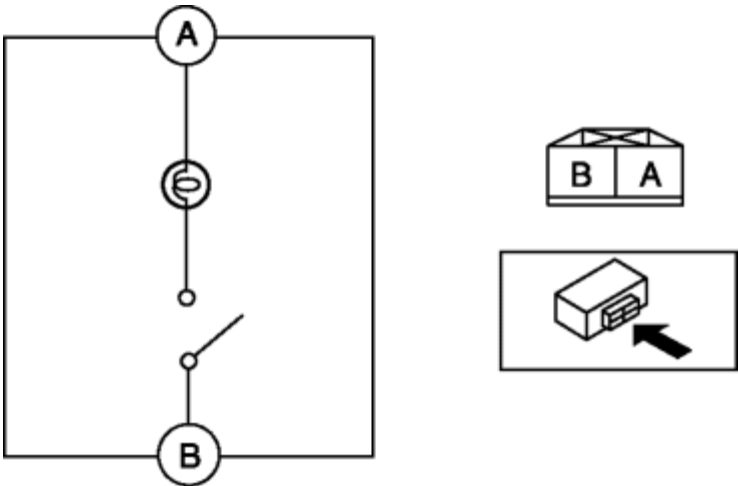
- 1. Remove the sunvisor. (See [SUNVISOR REMOVAL/ INSTALLATION.](#))
- 2. Verify that the continuity between the vanity mirror illumination terminals is as indicated in the table.

- If not as indicated in the table, inspect the bulb. If there is no malfunction, replace the sunvisor.

: Bulb
