## 2012 - Mazda6 - Body and Accessories

### ANTENNA FEEDER NO.1 INSPECTION

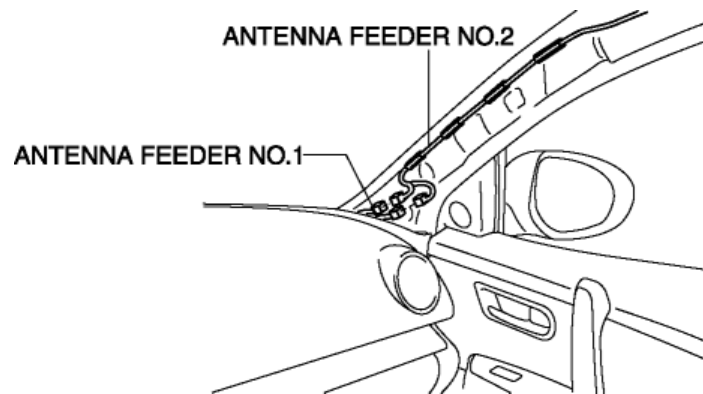
- j. A-pillar trim (RH) (See [A-PILLAR TRIM REMOVAL/ INSTALLATION.](#))
3. Disconnect the antenna feeder No.2.

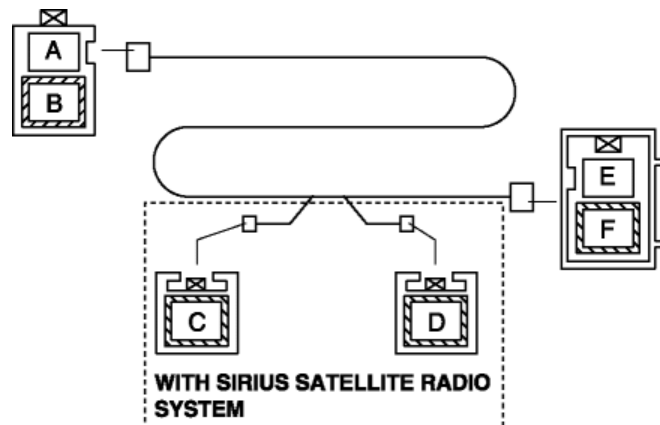
With audio system

4. Verify that the continuity between antenna feeder No.1 terminals is as indicated in the table.

○—○ : Continuity

| Test condition | Terminal | | | | | |
| | A | B | C | D | E | F |
| Under any condition | ○ | | | | ○ | |
| | | ○ | | | | ○ |
| | | | ○ | ○ <sup>*1</sup> | | |

**\*1 : WITH SIRIUS SATELLITE RADIO SYSTEM**

- If not as indicated in the table, replace antenna feeder No.1.

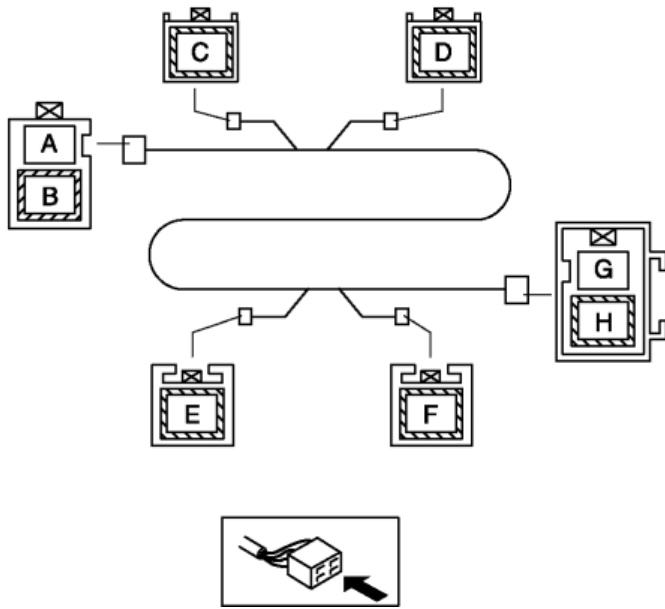
## WITHOUT ANTENNA FEEDER No.1 JACK TYPE

With car-navigation system

○—○ : Continuity

| Test condition | Terminal | | | | | | | |
| | A | B | C | D | E | F | G | H |
| Under any condition | ○ | | | | | | ○ | |
| | | ○ | | | | | | ○ |
| | | | ○ | ○ | | | | |
| | | | | | ○ | ○ | | |

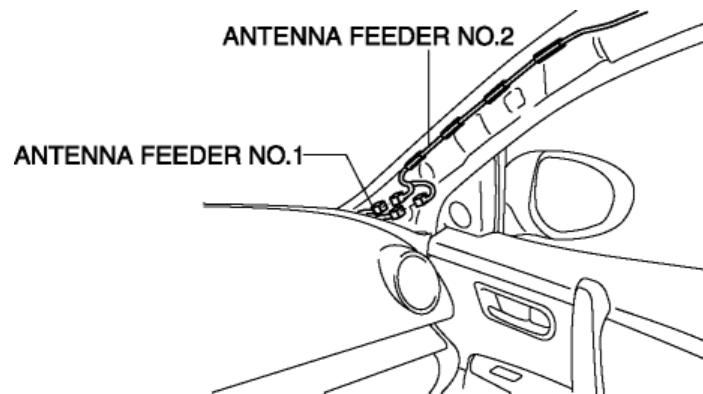
- j. A-pillar trim (RH) (See [A-PILLAR TRIM REMOVAL/ INSTALLATION.](#))
3. Disconnect the antenna feeder No.2.

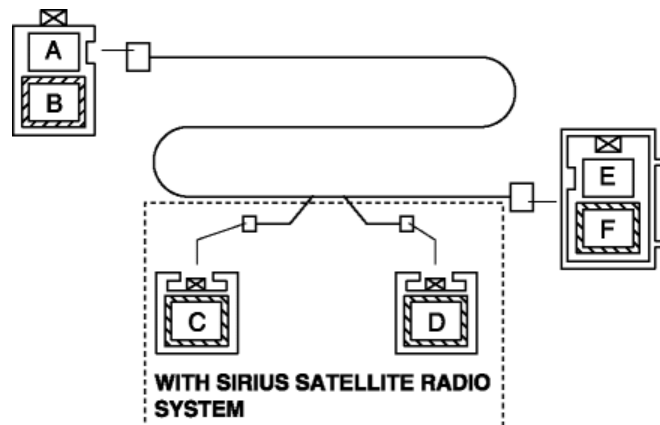
With audio system

4. Verify that the continuity between antenna feeder No.1 terminals is as indicated in the table.

○—○ : Continuity

| Test condition | Terminal | | | | | |
| | A | B | C | D | E | F |
| Under any condition | ○ | | | | ○ | |
| | | ○ | | | | ○ |
| | | | ○ | ○ <sup>*1</sup> | | |

**\*1 : WITH SIRIUS SATELLITE RADIO SYSTEM**

- If not as indicated in the table, replace antenna feeder No.1.

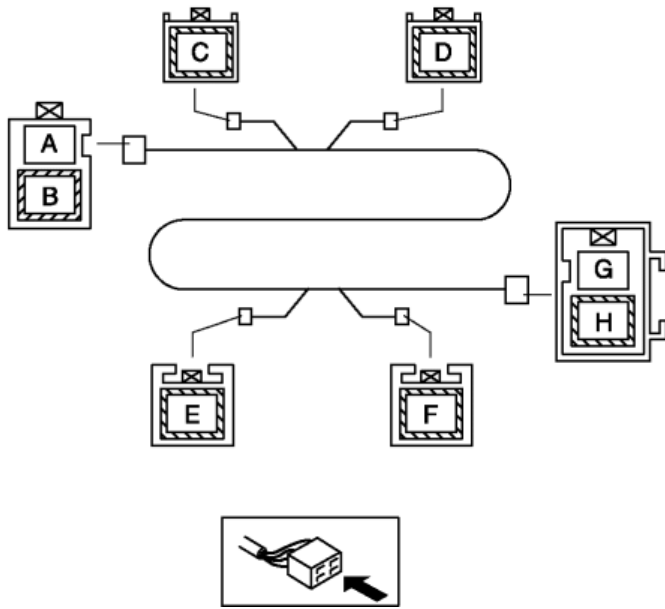
## WITHOUT ANTENNA FEEDER No.1 JACK TYPE

With car-navigation system

○—○ : Continuity

| Test condition | Terminal | | | | | | | |
| | A | B | C | D | E | F | G | H |
| Under any condition | ○ | | | | | | ○ | |
| | | ○ | | | | | | ○ |
| | | | ○ | ○ | | | | |
| | | | | | ○ | ○ | | |
