## 2012 - Mazda6 - Transmission/ Transaxle

### UP SWITCH INSPECTION [AY6A-EL]

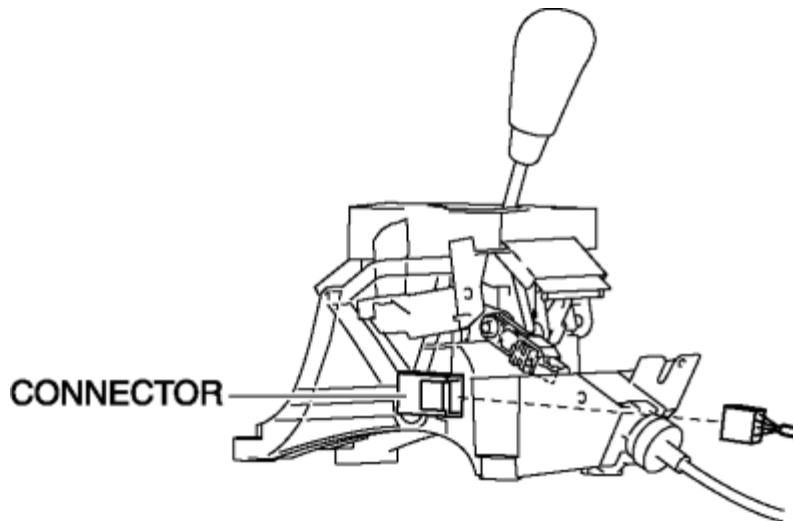
#### SELECTOR LEVER COMPONENT

1. Disconnect the selector lever component connector.

- a. Disconnect the negative battery cable.
- b. Remove the rear console. (See [REAR CONSOLE REMOVAL/ INSTALLATION.](#))
- c. Disconnect the selector lever component connector.

2. Measure the continuity between selector lever component terminals B and H.

- If there is any malfunction, replace the selector lever component. (See [AUTOMATIC TRANSAXLE SHIFT MECHANISM REMOVAL/ INSTALLATION.](#))

## Up switch specification

| Test condition | Continuity |
| M (+) | Continuity |
| Except M (+) | No continuity |

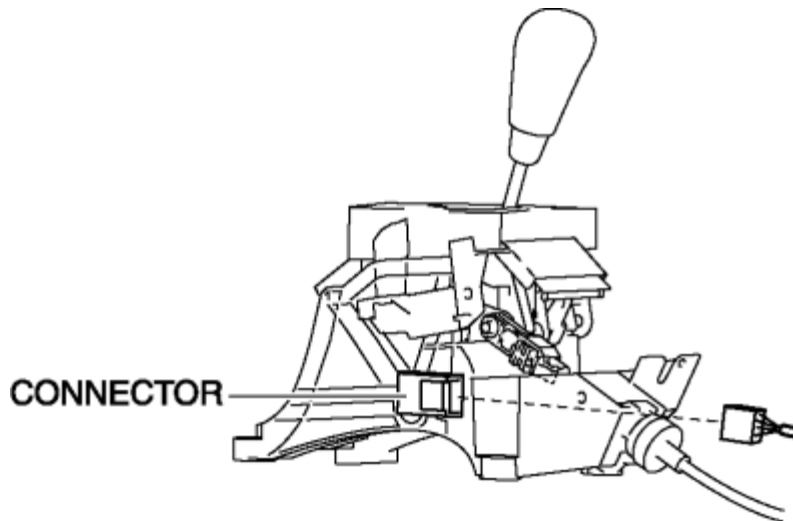
#### SELECTOR LEVER COMPONENT

1. Disconnect the selector lever component connector.

- a. Disconnect the negative battery cable.
- b. Remove the rear console. (See [REAR CONSOLE REMOVAL/ INSTALLATION.](#))
- c. Disconnect the selector lever component connector.

2. Measure the continuity between selector lever component terminals B and H.

- If there is any malfunction, replace the selector lever component. (See [AUTOMATIC TRANSAXLE SHIFT MECHANISM REMOVAL/ INSTALLATION.](#))

## Up switch specification

| Test condition | Continuity |
| M (+) | Continuity |
| Except M (+) | No continuity |
