## 2012 - Mazda6 - Transmission/ Transaxle

### LINE PRESSURE CONTROL SOLENOID INSPECTION [AY6A-EL]

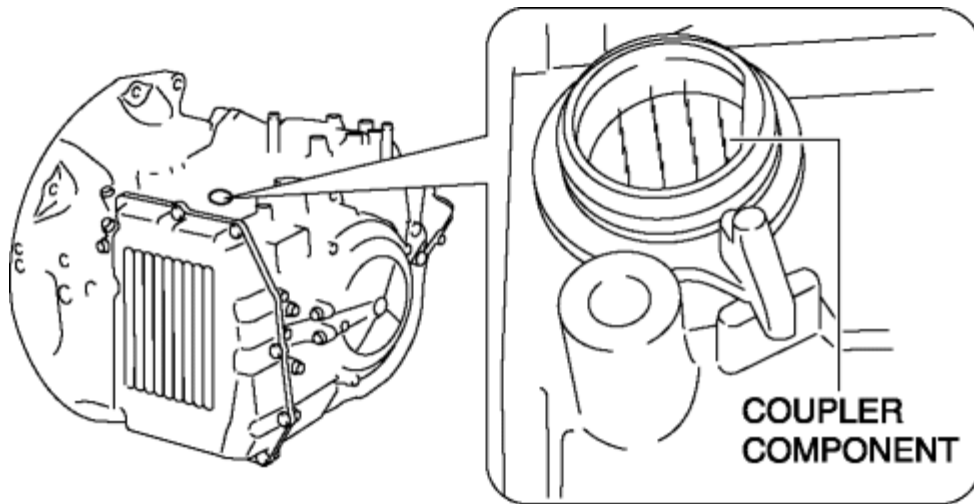
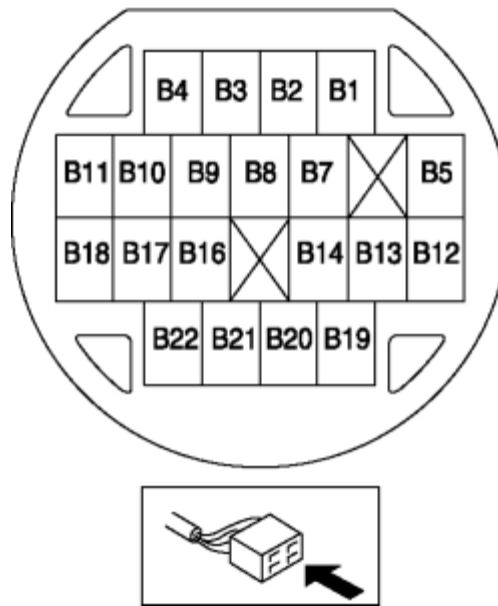
## COUPLER COMPONENT

1. Disconnect the negative battery cable.
2. Remove the fresh-air duct and air cleaner component as a single unit. (See [INTAKE-AIR SYSTEM REMOVAL/ INSTALLATION \[MZI 3.7 V6\]](#) .)
3. Remove the TCM. (See [TCM REMOVAL/ INSTALLATION \[AY6A-EL\]](#) .)
4. Measure the resistance between coupler component terminals B1 and B3.

| ATF temperature (°C {°F}) | Resistance (ohm) |
| 20 {68} | 5.0—5.6 |

- If there is any malfunction, inspect the coupler component for continuity. (See [COUPLER COMPONENT INSPECTION \[AY6A-EL\]](#).)
- If coupler component has no malfunction, perform the "Off-vehicle inspection". (See [Off-Vehicle Inspection](#).)

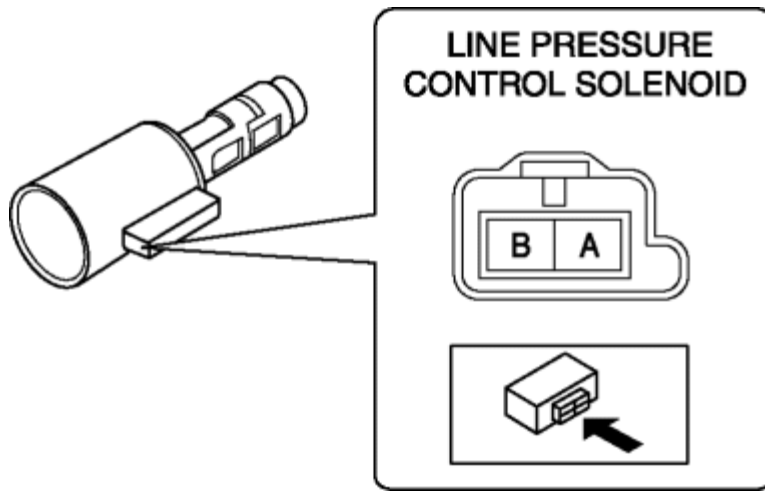
1. Measure the resistance line pressure control solenoid terminals A and B.

| Ambient temperature (°C {°F}) | Resistance (ohm) |
| 20 {68} | 5.0—5.6 |

- If there is any malfunction, replace the control valve body.

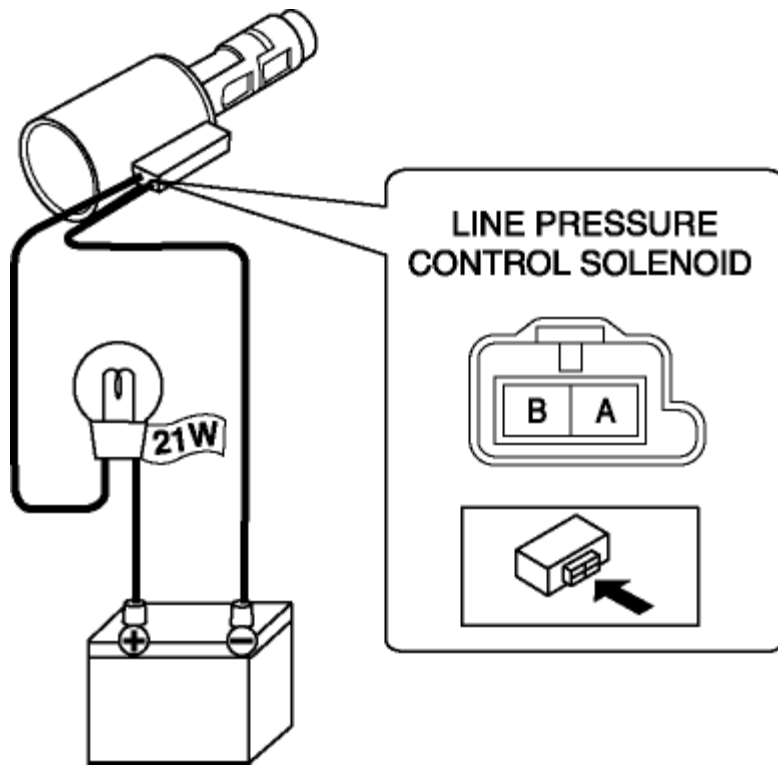
1. Connect the positive battery terminal to terminal B of line pressure control solenoid via the **12—21 W** bulb and connect the negative battery terminal to terminal A of line pressure control solenoid.

2. Verify that operating sound is heard from the line pressure control solenoid.

- If there is any malfunction, replace the control valve body.

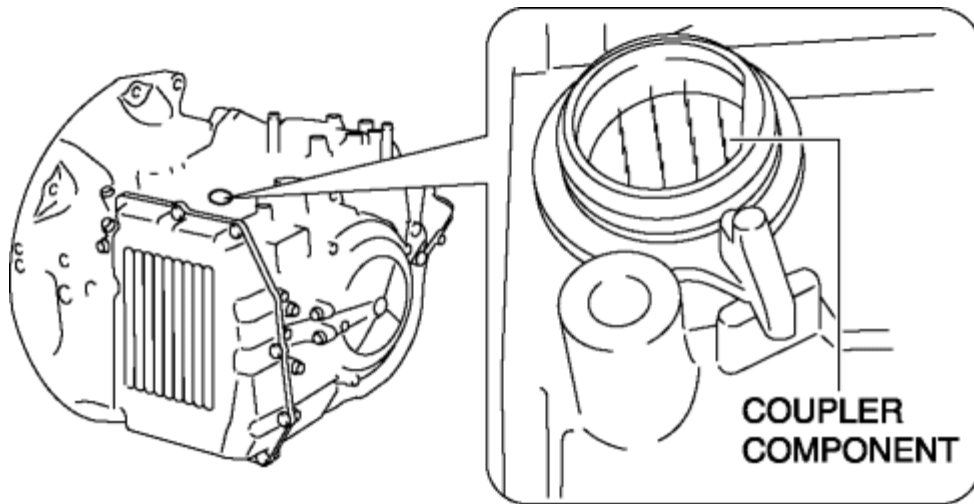
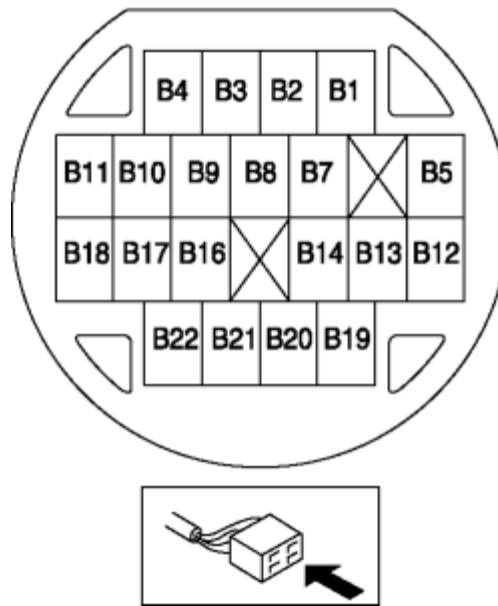
## COUPLER COMPONENT

1. Disconnect the negative battery cable.
2. Remove the fresh-air duct and air cleaner component as a single unit. (See [INTAKE-AIR SYSTEM REMOVAL/ INSTALLATION \[MZI 3.7 V6\]](#) .)
3. Remove the TCM. (See [TCM REMOVAL/ INSTALLATION \[AY6A-EL\]](#) .)
4. Measure the resistance between coupler component terminals B1 and B3.

| ATF temperature (°C {°F}) | Resistance (ohm) |
| 20 {68} | 5.0—5.6 |

- If there is any malfunction, inspect the coupler component for continuity. (See [COUPLER COMPONENT INSPECTION \[AY6A-EL\]](#).)
- If coupler component has no malfunction, perform the "Off-vehicle inspection". (See [Off-Vehicle Inspection](#).)

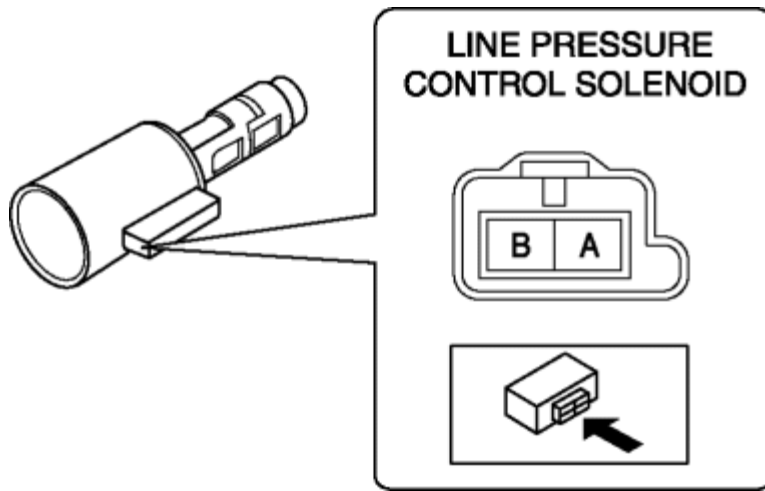
1. Measure the resistance line pressure control solenoid terminals A and B.

| Ambient temperature (°C {°F}) | Resistance (ohm) |
| 20 {68} | 5.0—5.6 |

- If there is any malfunction, replace the control valve body.

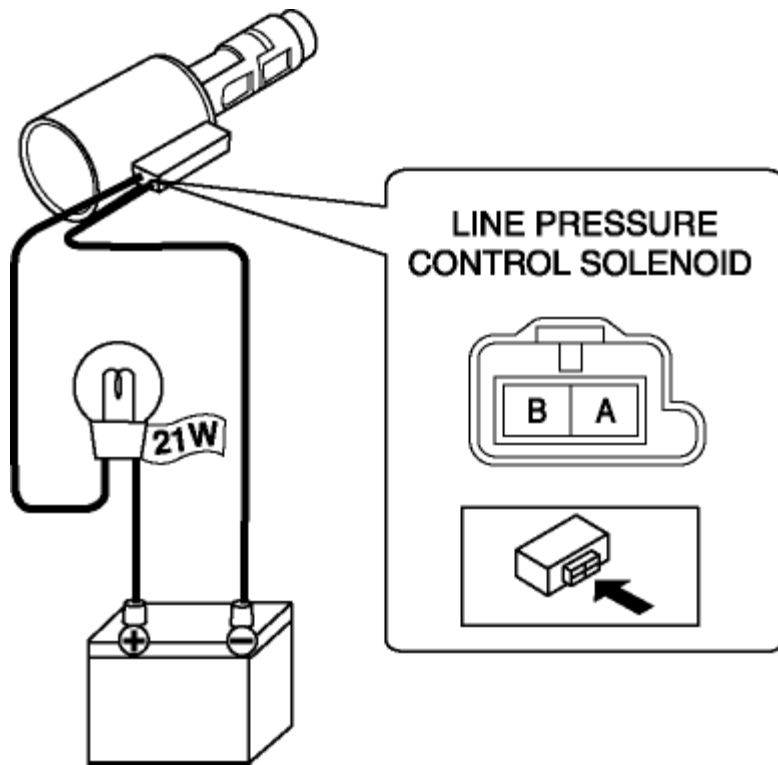
1. Connect the positive battery terminal to terminal B of line pressure control solenoid via the **12—21 W** bulb and connect the negative battery terminal to terminal A of line pressure control solenoid.

2. Verify that operating sound is heard from the line pressure control solenoid.

- If there is any malfunction, replace the control valve body.
