2012 - Mazda6 - Engine

CLUTCH PEDAL POSITION (CPP) SWITCH INSPECTION [MZR 2.5]

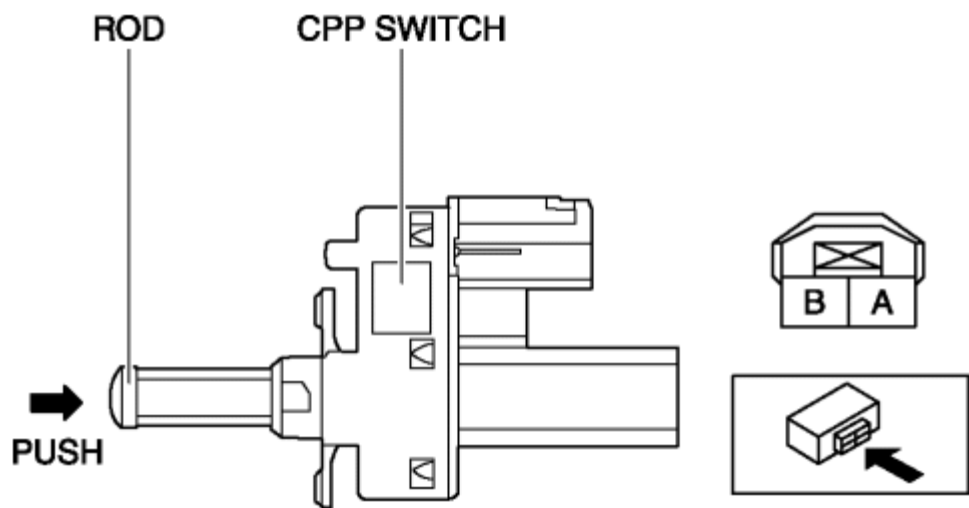
- 1. Verify that the CPP switch is installed properly.
- 2. Disconnect the negative battery cable. (See [BATTERY REMOVAL/ INSTALLATION \[MZR 2.5\]](#).)
- 3. Disconnect CPP switch connector. (See [CLUTCH PEDAL REMOVAL/ INSTALLATION \[G66M-R\]](#).)
- 4. Inspect for continuity between CPP switch terminals A and B.

- If not as specified, replace the CPP switch. (See [CLUTCH PEDAL REMOVAL/ INSTALLATION \[G66M-R\]](#).)

CPP switch specification

| Measured condition | Clutch pedal position | Continuity |
| Rod pushed | Clutch pedal released | Continuity detected |
| Except above | Clutch pedal depressed | No continuity |

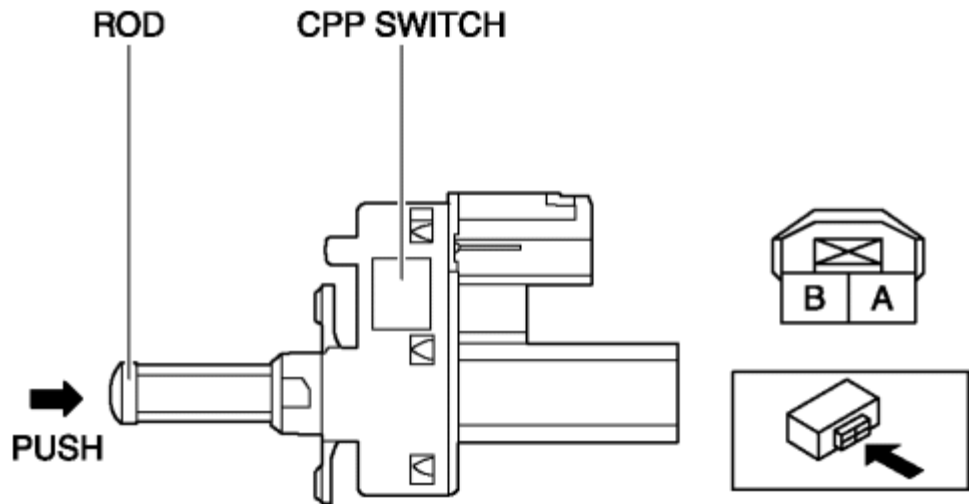
- 1. Verify that the CPP switch is installed properly.
- 2. Disconnect the negative battery cable. (See [BATTERY REMOVAL/ INSTALLATION \[MZR 2.5\]](#).)
- 3. Disconnect CPP switch connector. (See [CLUTCH PEDAL REMOVAL/ INSTALLATION \[G66M-R\]](#).)
- 4. Inspect for continuity between CPP switch terminals A and B.

- If not as specified, replace the CPP switch. (See [CLUTCH PEDAL REMOVAL/ INSTALLATION \[G66M-R\]](#).)

CPP switch specification

| Measured condition | Clutch pedal position | Continuity |
| Rod pushed | Clutch pedal released | Continuity detected |
| Except above | Clutch pedal depressed | No continuity |
