2012 - Mazda6 - Body and Accessories

DTC: 09:Er20, DEVICE CORD 09/ ERROR CORD 20 [AUDIO]

| DESCRIPTION | Audio unit power supply voltage is low |

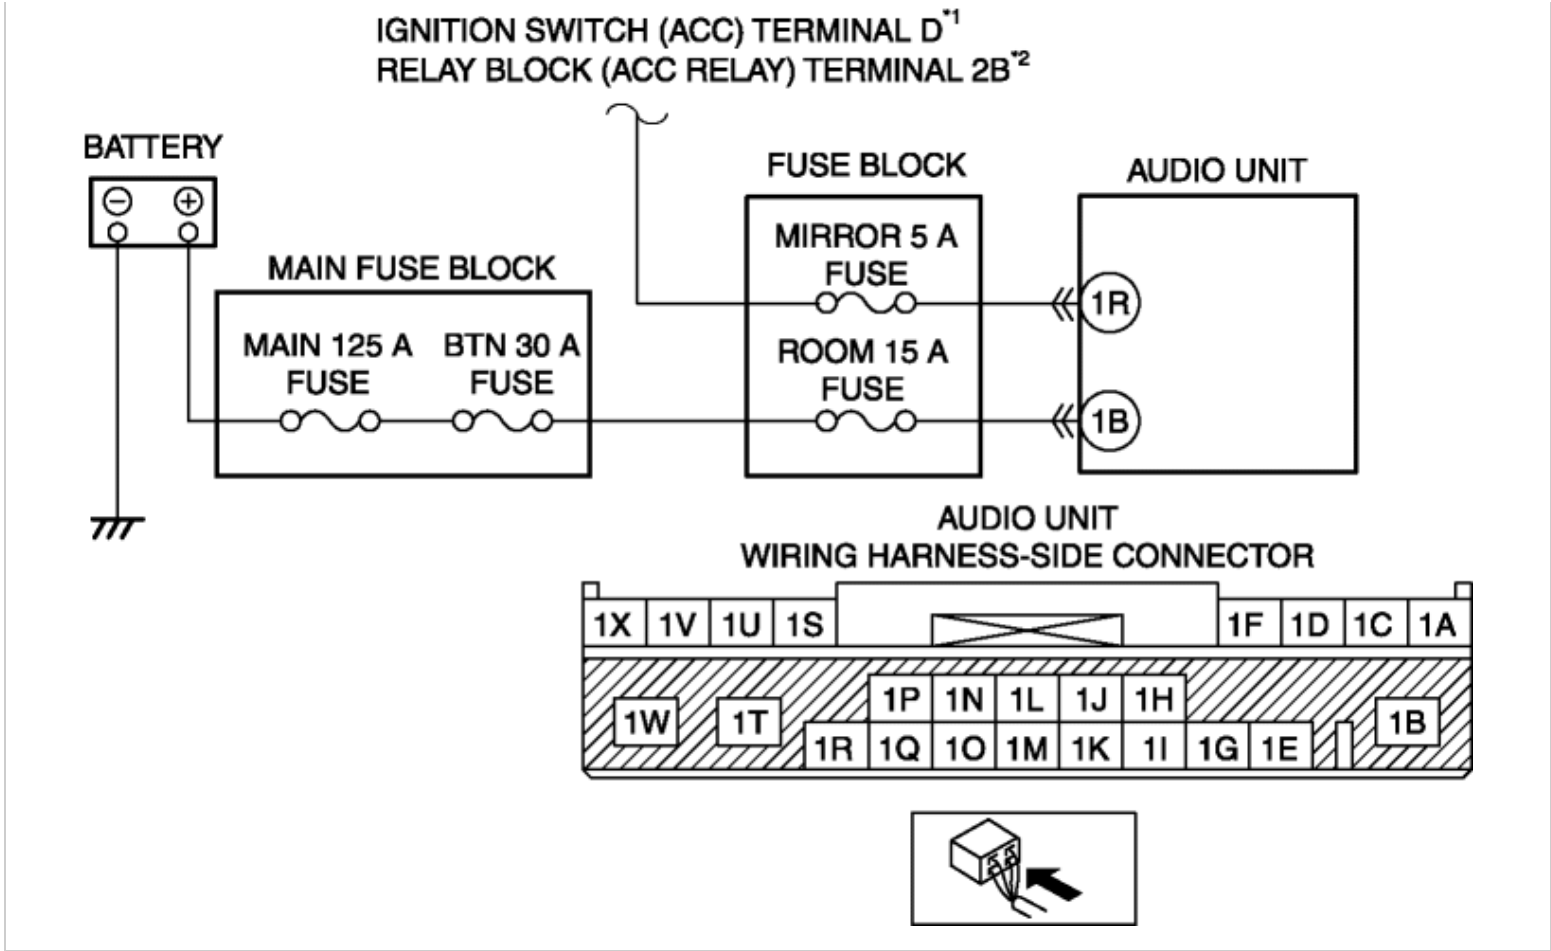
- \*1  
Vehicles without advanced keyless entry and push button start system
- \*2  
Vehicles with advanced keyless entry and push button start system

| POSSIBLE CAUSE | <ul style="list-style-type: none"><li>• PCM DTC is stored</li><li>• Battery malfunction</li><li>• Generator malfunction</li><li>• Audio unit connector or terminals malfunction</li><li>• Open circuit or short to ground in wiring harness between the following terminals:<ul style="list-style-type: none"><li>▪ Audio unit terminal 1R—Ignition switch terminal D*<sup>1</sup>/Relay block terminal 2B*<sup>2</sup></li><li>▪ Audio unit terminal 1B—Battery positive terminal</li></ul></li><li>• Fuse malfunction</li><li>• Audio unit malfunction</li></ul> |

| 4 | <p><b>INSPECT AUDIO UNIT CONNECTOR CONDITION</b></p> <ul style="list-style-type: none"> <li>Switch the ignition to off.</li> <li>Disconnect the negative battery cable.</li> <li>Disconnect the audio unit connector.</li> <li>Inspect the connector for poor connection (such as damaged/pulled-out pins, and corrosion).</li> <li>Is there any malfunction?</li> </ul> | <p>Yes Repair or replace the connector or terminal, then go to Step 6.</p> | No Go to the next step. |
