## 2012 - Mazda6 - Brakes

### REAR BRAKE (DISC) INSPECTION

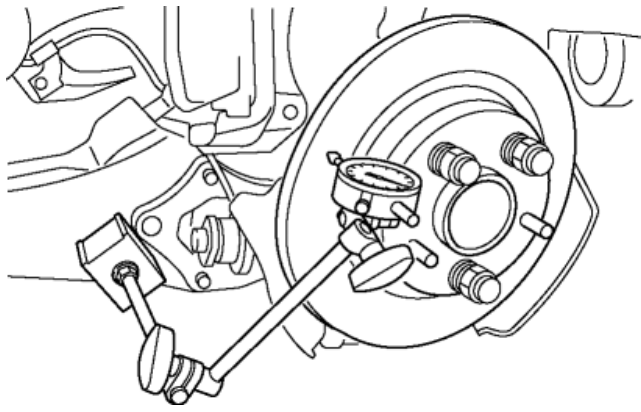
#### Lateral runout inspection

2. After tightening all the hub nuts to the same torque, put the dial gauge on the friction surface of disc plate **10 mm { 0.39 in }** from the disc plate edge.

3. Rotate the disc plate one time and measure the runout.

**Rear disc plate runout limit**

- 0.14 mm {0.0055 in}

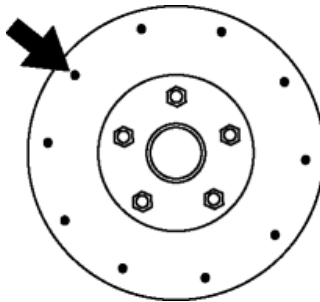
**Thickness variation inspection**

1. Clean the disc plate-to-pad friction surface using a brake cleaner.
2. Measure the points indicated in the illustration using a caliper (micrometer).

3. Subtract the minimum value from the maximum, and if the result is not within specification, machine the disc plate using a lathe.

**Thickness variation limit**

- 0.015 mm {0.00059 in}

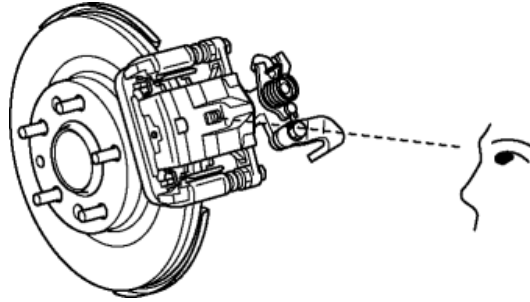
**Disc Pad Thickness Inspection**

1. Jack up the front of the vehicle and support it with safety stands.
2. Remove the wheel and tires.
3. Verify the remaining thickness of the pads.

**Minimum rear disc pad thickness**

- 2.0 mm {0.079 in} min.
