## 2012 - Mazda6 - Brakes

### FRONT BRAKE (DISC) INSPECTION

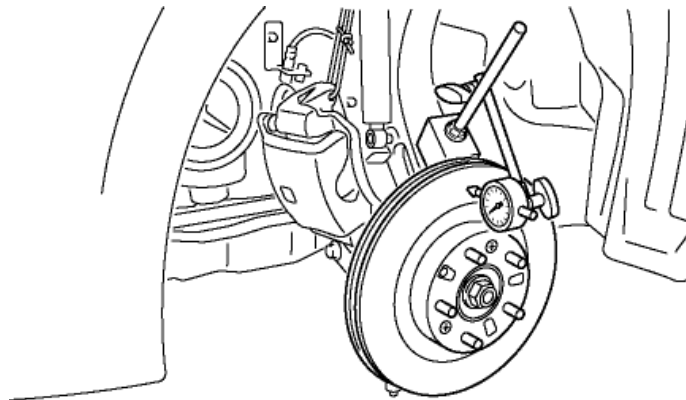
1. Put the dial gauge on the friction surface of disc plate **10 mm {0.39 in}** from the disc plate edge.

2. Rotate the disc plate one time and measure the runout.

**Front disc plate runout limit**

- 0.05 mm {0.002 in}

- If the runout is **more than 0.05 mm { 0.002 in}** at the position **10 mm { 0.39 in}** from the disc plate edge, uneven wear occurs on the disc plate because the pad contacts the plate unevenly.
- If the runout is **less than 0.05 mm { 0.002 in}** , uneven wear does not occur.

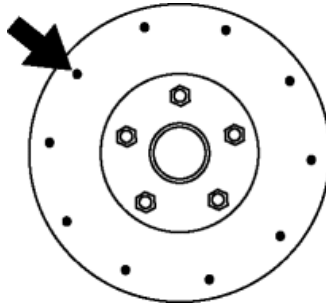
1. Clean the disc plate-to-pad friction surface using a brake cleaner.
2. Measure the points indicated in the illustration using a caliper (micrometer).

3. Subtract the minimum value from the maximum, and if the result is not within specification, machine the disc plate using a lathe.

#### Thickness variation limit

- 0.015 mm {0.00059 in}

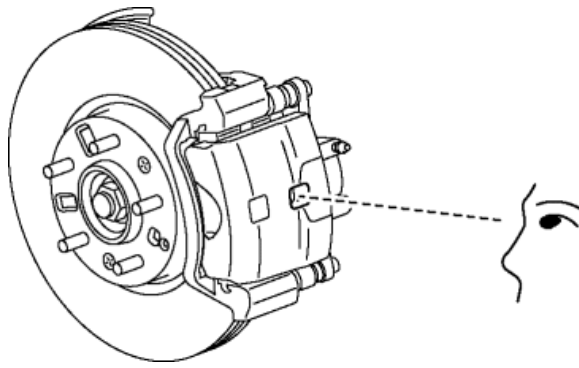
1. Jack up the front of the vehicle and support it with safety stands.
2. Remove the wheel and tires.
3. Verify the remaining thickness of the pads.

**Minimum front disc pad thickness**

- 2.0 mm {0.08 in} min.

4. Replace the pads as a set: right and left wheels, if either one is at or less than the minimum thickness.

4. Replace the pads as a set: right and left wheels, if either one is at or less than the minimum thickness.
