2012 - Mazda6 - Transmission/ Transaxle

TCM REMOVAL/ INSTALLATION [FS5A-EL]

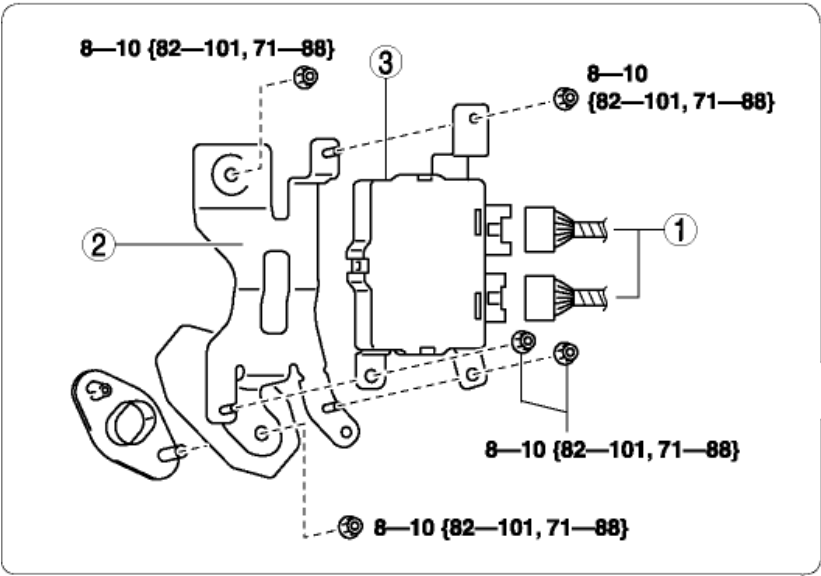
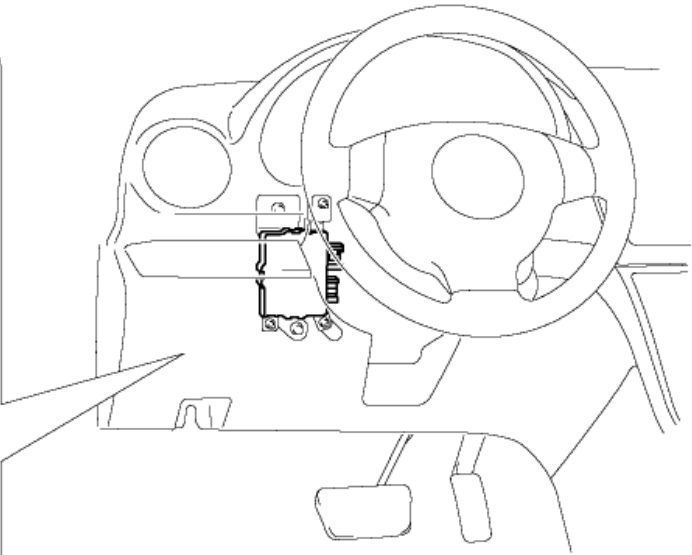
- Water or foreign objects entering the connector can cause a poor connection or corrosion. Be sure not to drop water or foreign objects on the connector when disconnecting it.
1. Disconnect the negative battery cable.
  2. Remove in the order indicated in the table.
  3. Install in the reverse order of removal.

| 1 | Connector |
| 2 | Bracket |
| 3 | TCM |

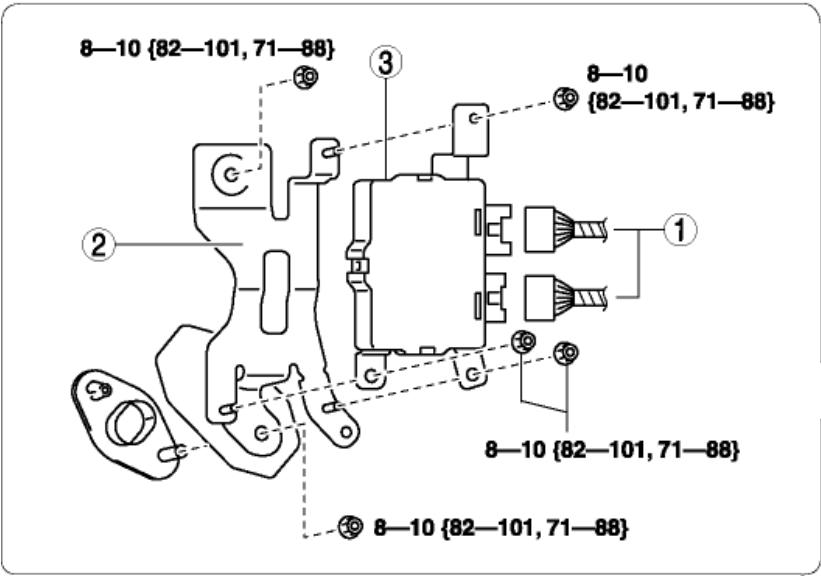
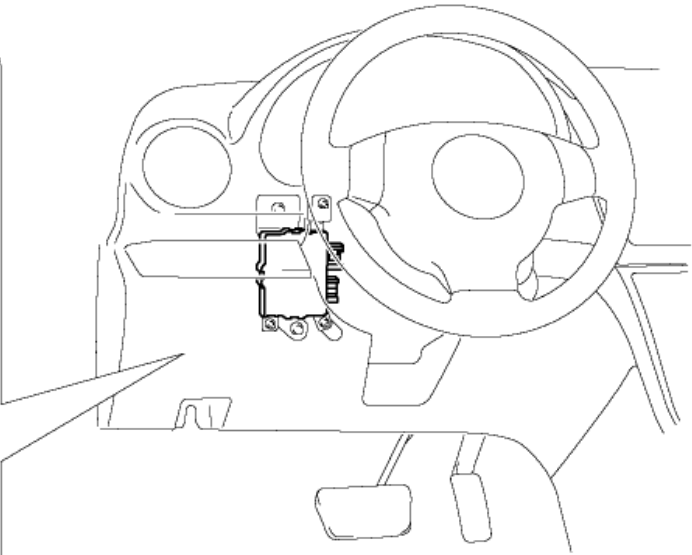
- Water or foreign objects entering the connector can cause a poor connection or corrosion. Be sure not to drop water or foreign objects on the connector when disconnecting it.
1. Disconnect the negative battery cable.
  2. Remove in the order indicated in the table.
  3. Install in the reverse order of removal.

| 1 | Connector |
| 2 | Bracket |
| 3 | TCM |
