## 2012 - Mazda6 - Transmission/ Transaxle

### DOWN SWITCH INSPECTION [FS5A-EL]

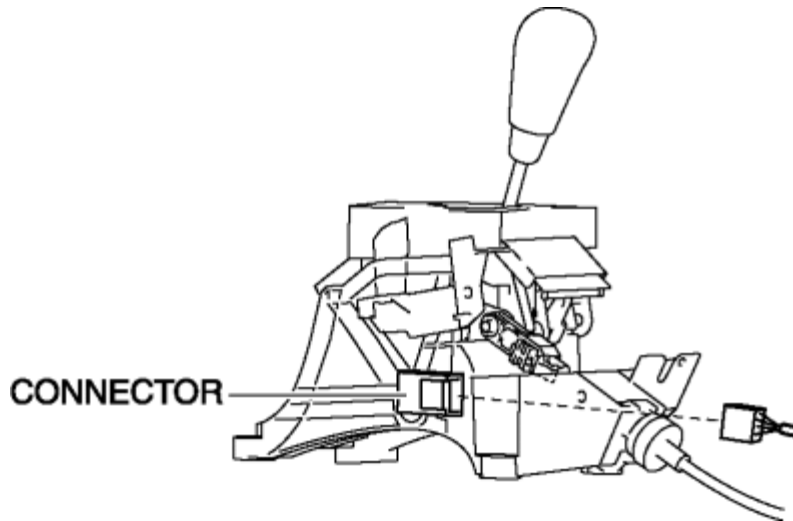
#### SELECTOR LEVER COMPONENT

- Water or foreign objects entering the connector can cause a poor connection or corrosion. Be sure not to drop water or foreign objects on the connector when disconnecting it.
1. Disconnect the selector lever component connector.
    - a. Disconnect the negative battery cable.
    - b. Remove the rear console. (See [REAR CONSOLE REMOVAL/ INSTALLATION.](#))
    - c. Disconnect the selector lever component connector.

2. Measure the continuity between selector lever component terminals C and H.

- If there is any malfunction, replace the selector lever component. (See [AUTOMATIC TRANSAXLE SHIFT MECHANISM REMOVAL/ INSTALLATION.](#))

#### Down switch specification

| Test condition | Continuity |
| M (–) | Continuity |
| Except M (–) | No continuity |

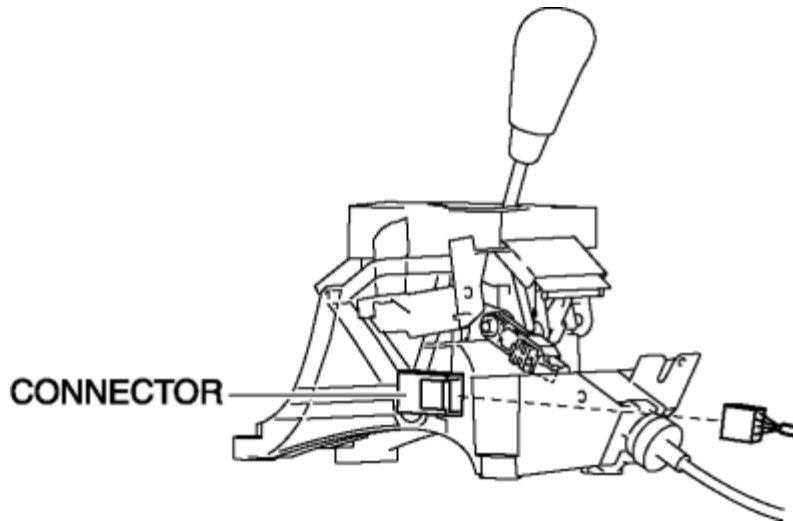
#### SELECTOR LEVER COMPONENT

- Water or foreign objects entering the connector can cause a poor connection or corrosion. Be sure not to drop water or foreign objects on the connector when disconnecting it.
1. Disconnect the selector lever component connector.
    - a. Disconnect the negative battery cable.
    - b. Remove the rear console. (See [REAR CONSOLE REMOVAL/ INSTALLATION.](#))
    - c. Disconnect the selector lever component connector.

2. Measure the continuity between selector lever component terminals C and H.

- If there is any malfunction, replace the selector lever component. (See [AUTOMATIC TRANSAXLE SHIFT MECHANISM REMOVAL/ INSTALLATION.](#))

#### Down switch specification

| Test condition | Continuity |
| M (–) | Continuity |
| Except M (–) | No continuity |
