## 2012 - Mazda6 - Body and Accessories

### FILAMENT INSPECTION

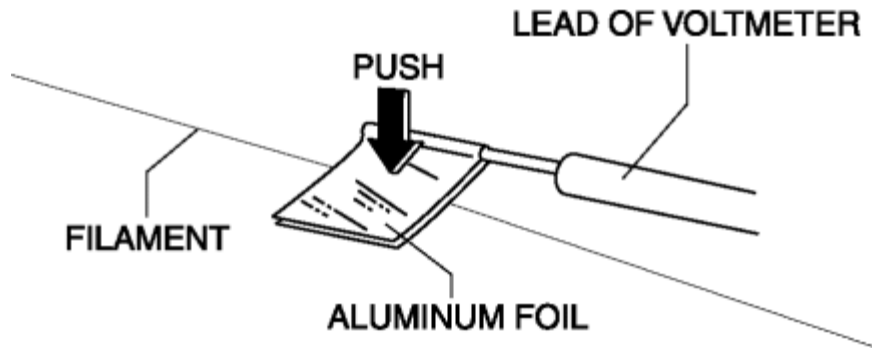
- Directly touching the rear window defroster filament with the lead of the tester could damage it. Wrap aluminum foil around the end of the lead and inspect the filament by touching it with the foil.
3. Connect the positive lead of the tester to the positive side of each filament and the negative lead to ground.
  4. Gradually slide the positive lead from the positive side to the negative side and verify that the voltage decreases accordingly.

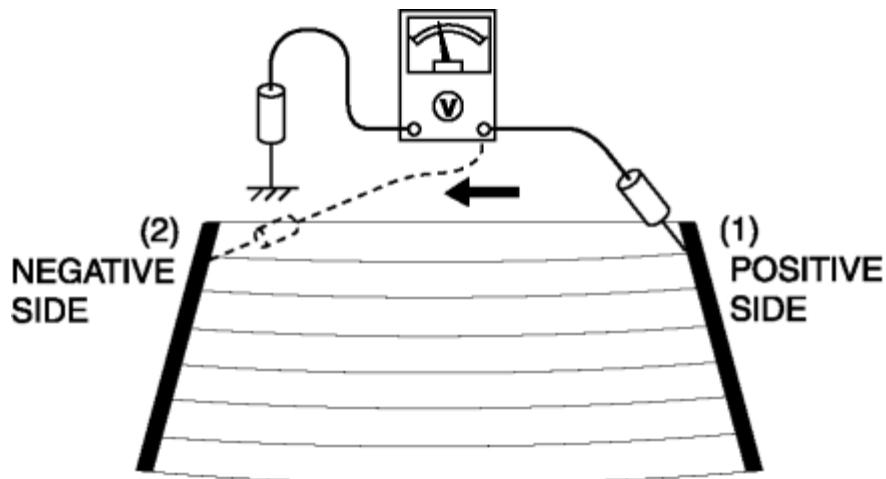
- If the voltage changes rapidly, the filament has a malfunction. Repair the filament.

| Measured part | Voltage (Reference) |

| (1) to (2) | Approx. 11 V to 0 V |

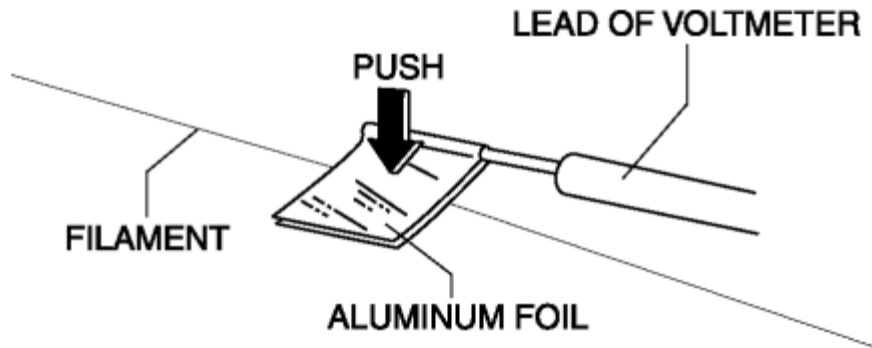
- Directly touching the rear window defroster filament with the lead of the tester could damage it. Wrap aluminum foil around the end of the lead and inspect the filament by touching it with the foil.
3. Connect the positive lead of the tester to the positive side of each filament and the negative lead to ground.
  4. Gradually slide the positive lead from the positive side to the negative side and verify that the voltage decreases accordingly.

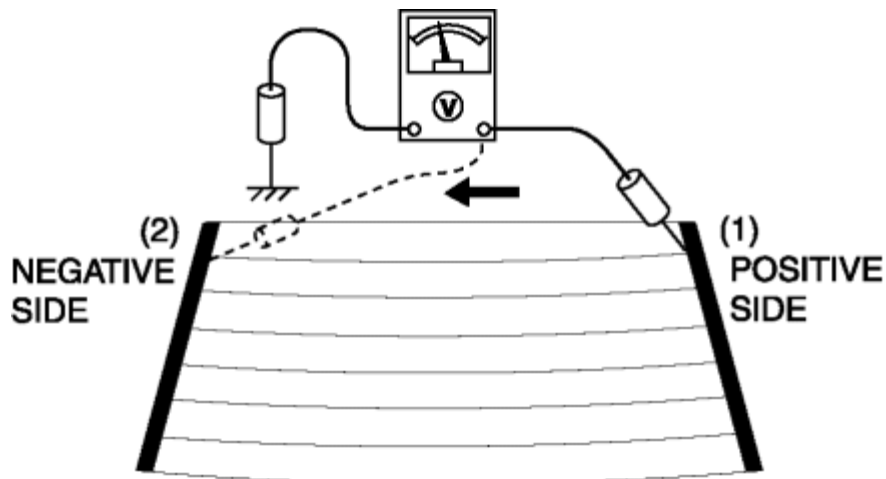
- If the voltage changes rapidly, the filament has a malfunction. Repair the filament.

| Measured part | Voltage (Reference) |

| (1) to (2) | Approx. 11 V to 0 V |
