2012 - Mazda6 - Body and Accessories

TWEETER INSPECTION

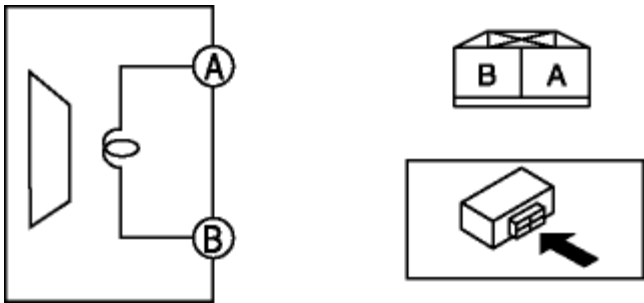
- 1. Disconnect the negative battery cable.
- 2. Remove the inner garnish. (See [INNER GARNISH REMOVAL/ INSTALLATION](#).)
- 3. Remove the tweeter. (See [TWEETER REMOVAL/ INSTALLATION](#).)
- 4. Verify the resistance between tweeter terminals.

- If not within the specification, replace the tweeter.

- Without Bose®: 3.4—4.6 ohms
- With Bose®: 3.06—3.94 ohms

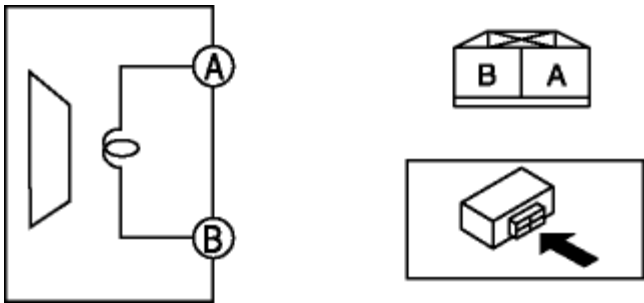
- 1. Disconnect the negative battery cable.
- 2. Remove the inner garnish. (See [INNER GARNISH REMOVAL/ INSTALLATION](#).)
- 3. Remove the tweeter. (See [TWEETER REMOVAL/ INSTALLATION](#).)
- 4. Verify the resistance between tweeter terminals.

- If not within the specification, replace the tweeter.

- Without Bose®: 3.4—4.6 ohms
- With Bose®: 3.06—3.94 ohms
