## 2012 - Mazda6 - Transmission/ Transaxle

### DOWN SWITCH INSPECTION [AY6A-EL]

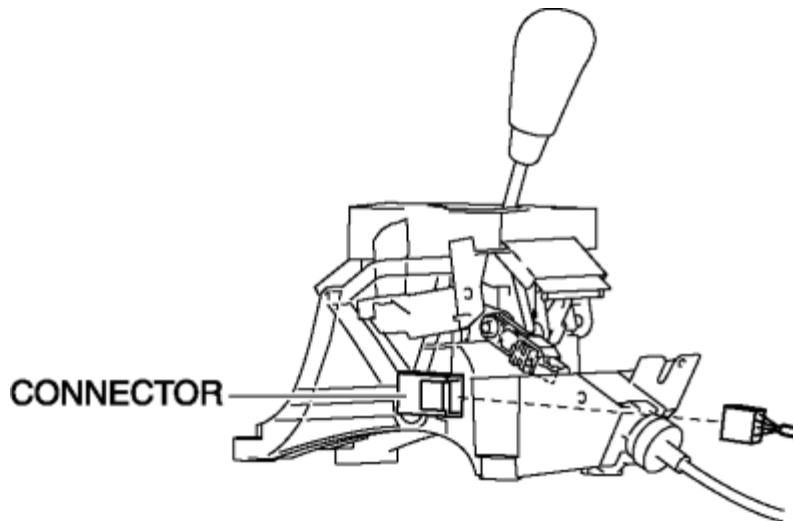
#### SELECTOR LEVER COMPONENT

1. Disconnect the selector lever component connector.

- a. Disconnect the negative battery cable.
- b. Remove the rear console. (See [REAR CONSOLE REMOVAL/ INSTALLATION.](#))
- c. Disconnect the selector lever component connector.

2. Measure the continuity between selector lever component terminals C and H.

- If there is any malfunction, replace the selector lever component. (See [AUTOMATIC TRANSAXLE SHIFT MECHANISM REMOVAL/ INSTALLATION.](#))

**Down switch specification**

| Test condition | Continuity |
| M (－) | Continuity |
| Except M (－) | No continuity |

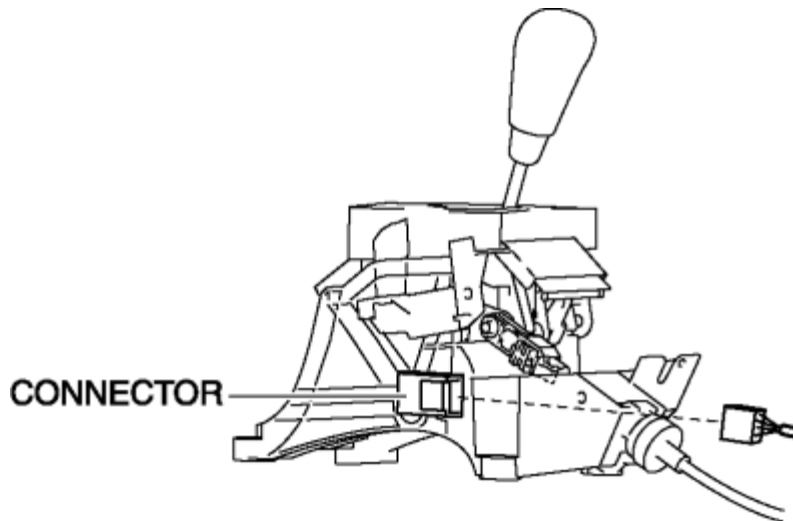
#### SELECTOR LEVER COMPONENT

1. Disconnect the selector lever component connector.

- a. Disconnect the negative battery cable.
- b. Remove the rear console. (See [REAR CONSOLE REMOVAL/ INSTALLATION.](#))
- c. Disconnect the selector lever component connector.

2. Measure the continuity between selector lever component terminals C and H.

- If there is any malfunction, replace the selector lever component. (See [AUTOMATIC TRANSAXLE SHIFT MECHANISM REMOVAL/ INSTALLATION.](#))

**Down switch specification**

| Test condition | Continuity |
| M (－) | Continuity |
| Except M (－) | No continuity |
