2012 - Mazda6 - Body and Accessories

KEY REMINDER SWITCH INSPECTION [WITHOUT ADVANCED KEYLESS ENTRY AND PUSH BUTTON START SYSTEM]

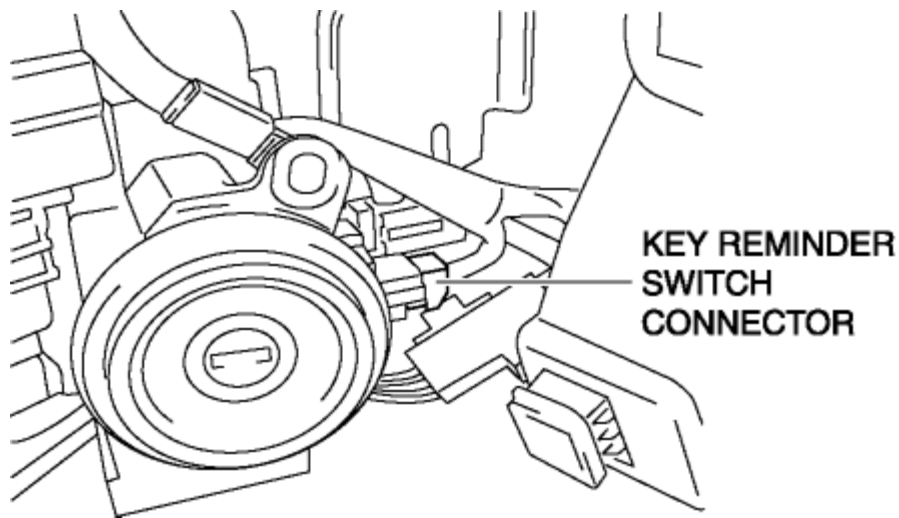
- 1. Disconnect the negative battery cable.
- 2. Remove the column cover. (See [COLUMN COVER REMOVAL/ INSTALLATION.](#))
- 3. Disconnect the key reminder switch connector.

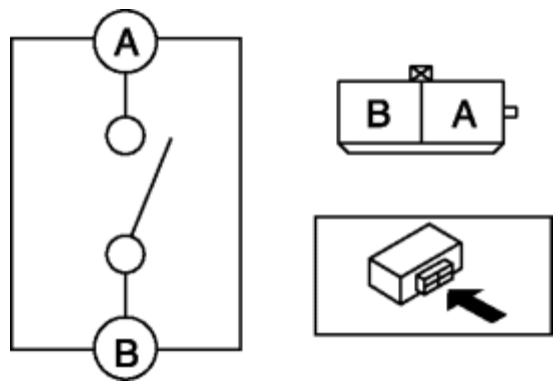
- 4. Verify that the continuity between the key reminder switch terminals is as indicated in the table.

- If not as indicated in the table, replace the key reminder switch.

○—○ : Continuity

| Key position | Terminal | |
| | A | B |
| Key inserted | ○ ——— ○ | |
| Key removed | | |

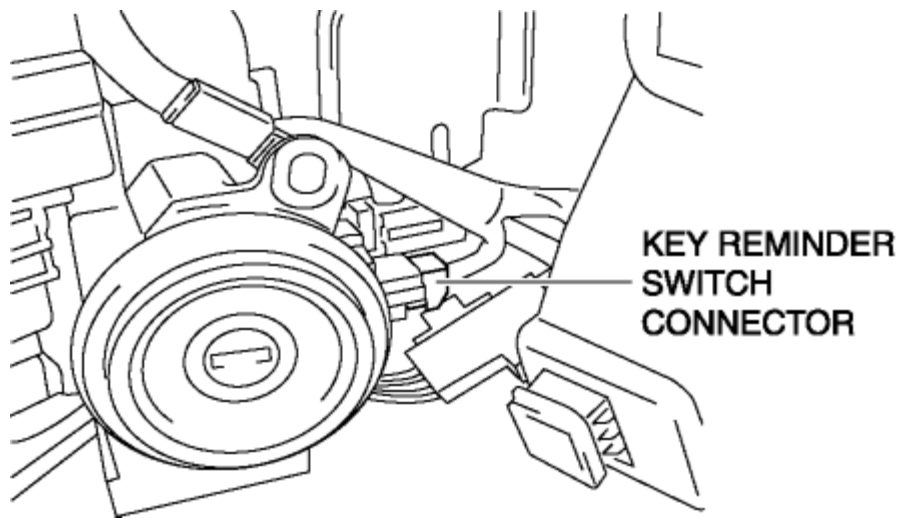
- 1. Disconnect the negative battery cable.
- 2. Remove the column cover. (See [COLUMN COVER REMOVAL/ INSTALLATION.](#))
- 3. Disconnect the key reminder switch connector.

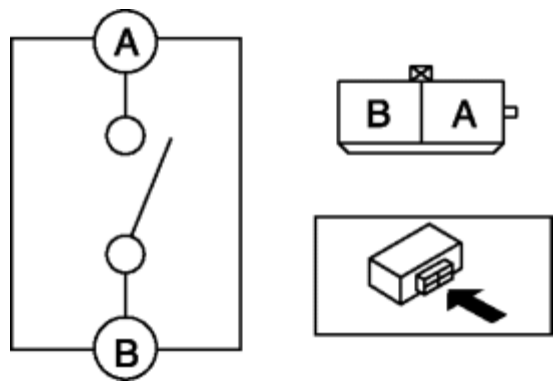
- 4. Verify that the continuity between the key reminder switch terminals is as indicated in the table.

- If not as indicated in the table, replace the key reminder switch.

○—○ : Continuity

| Key position | Terminal | |
| | A | B |
| Key inserted | ○ ——— ○ | ○ ——— ○ |
| Key removed | | |
